SEMEQ – Global Beverage Industry

August 23rd , 2023

Results – Potential Downtime Avoidance

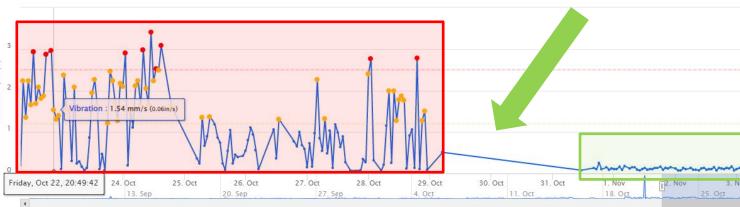
FILLER -> INFEED GEARBOX

POOR LUBRICATION

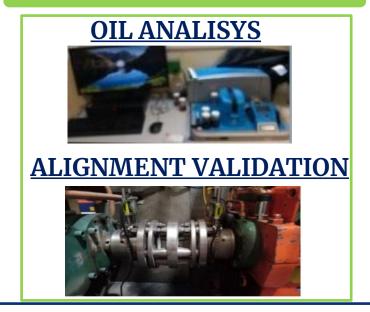
FIELD INVESTIGATION

COUPLING AND LUBRICATION
