Bulletin SEMEQ

SEMEQ / STEEL MILL COMPANY

Focus on Predictive Maintenance

Melt shop - Near Net Caster - 2 Fresh Water Pump

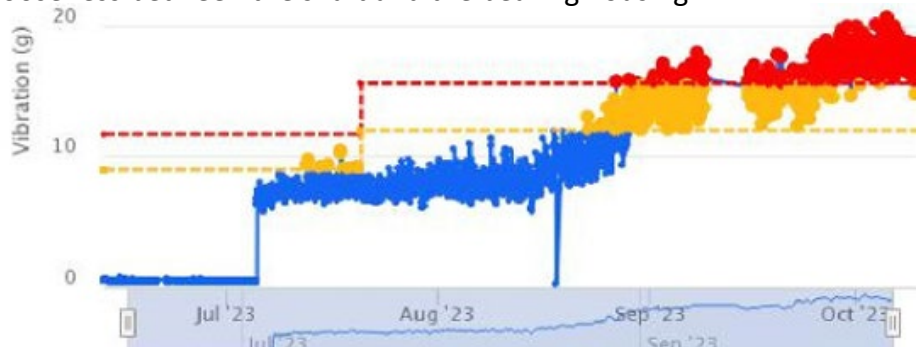
Tendency Curve

Diagnostic: Mounting Shaft Looseness

Component: Bearing

Recommendation action: The vibration level increased around the bearing resonance frequency in acceleration RMS and harmonics of 1x machine speed frequency were shown on the envelope spectrum. It is normally caused by excessive clearance of the bearings and fixing the looseness between the shaft and the bearing housing.
