**Save 800 mil dollars  
we explain**

# COST AVOIDANCE

# ONLINE SYSTEM

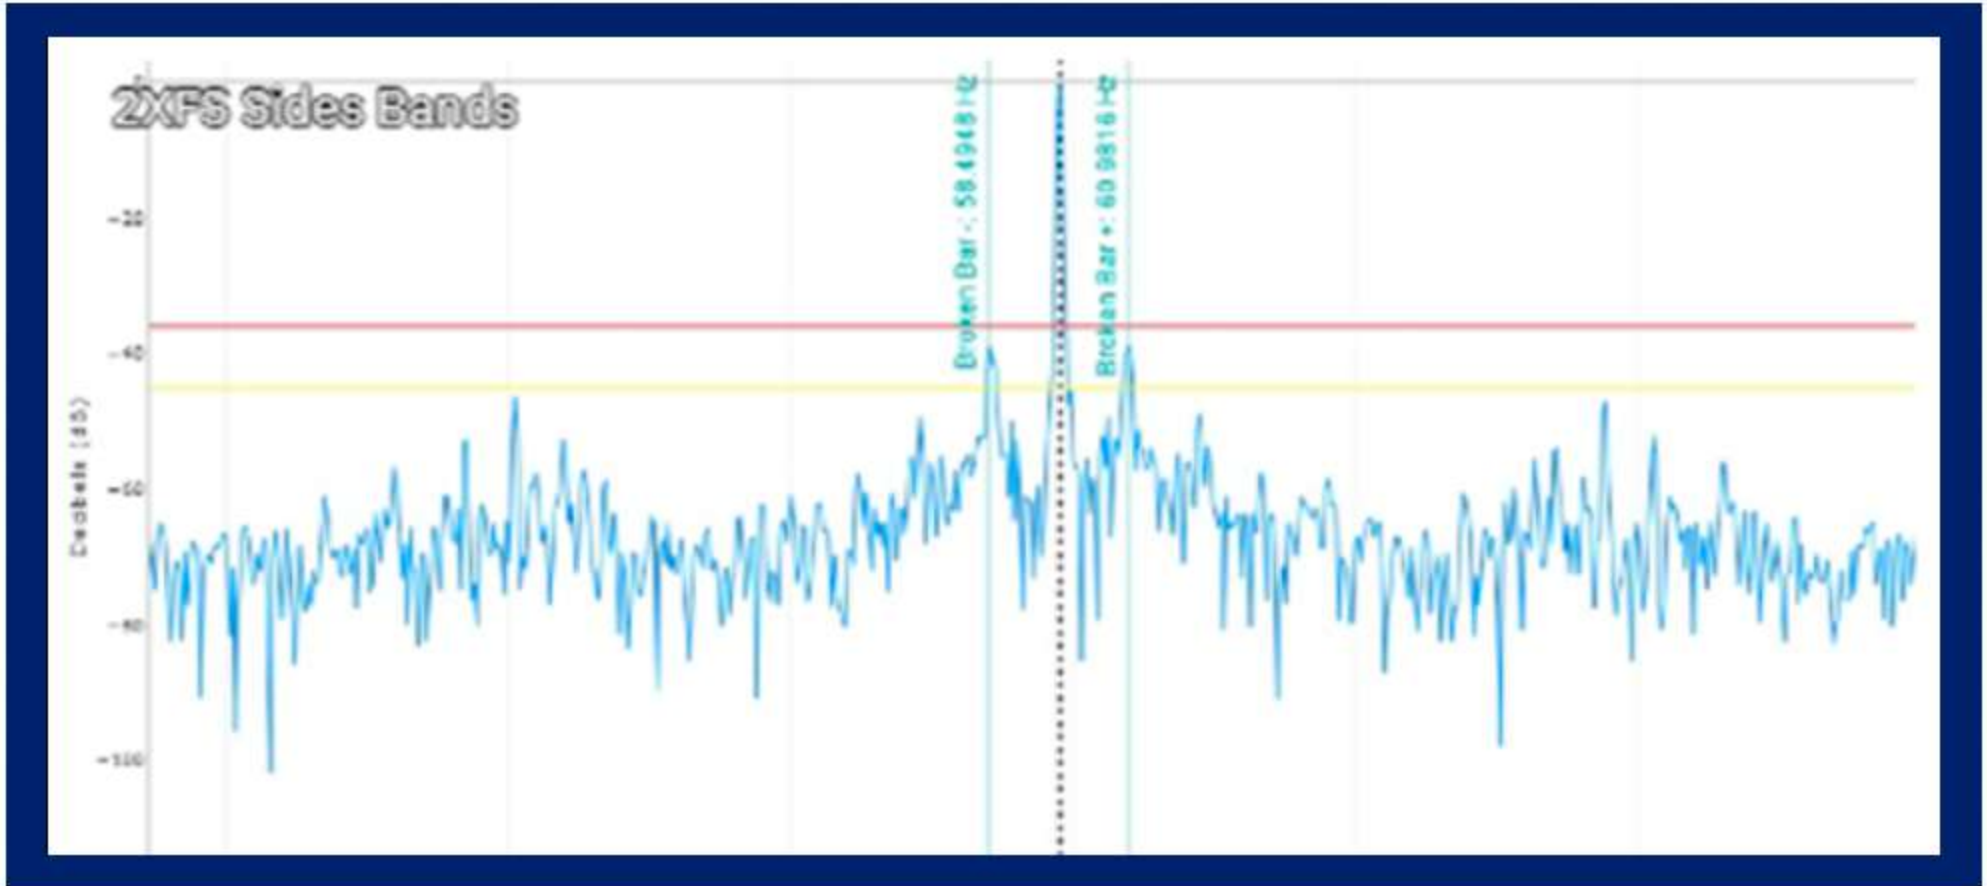
The vibration system identified an electrical frequency of 120 Hz—twice line frequency—suggesting an electrical issue. We observed an amplitude of around 2.5g in the envelope for the main motor. Let's explore this further together!

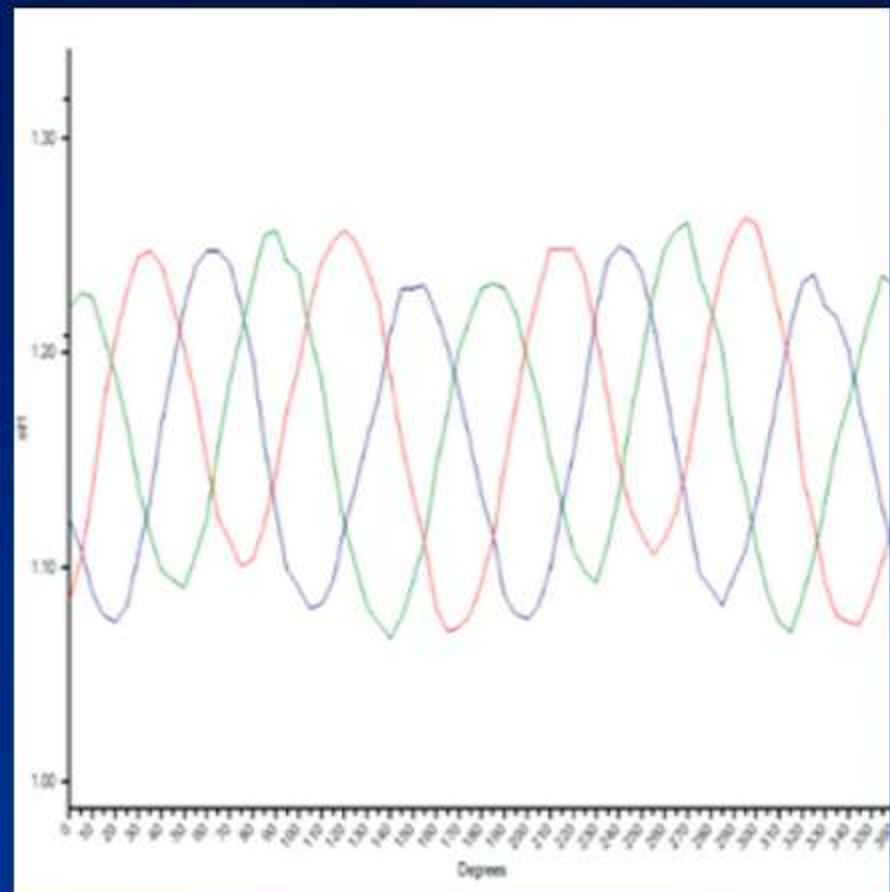
We checked over the Elektron MCA for a deeper insight into electrical frequency! We've identified the Short Circuit Frequency (SCF) and the Broken Bar Frequency (BBF), enhancing our understanding.

A	B	C
Test Date	04/06/18	02/14/19	09/18/24
Test Time	6:18 AM	12:25 PM	2:10 PM
Test Location	Motor Leads	Motor Leads	Junction Box
User	Administrator	Administrator	Administrator
Tester Serial	5904	5904	5904
MTAP ID			
	Baseline		
Frequency	1200	1200	1200
Charge Time	600	600	600
Voltage	500	500	500
Motor Temp °F	104	59	90
Measured Mohm	3,830.82	3,704.53	144.14
Corrected Mohm	3,830.82	650.00	83.90
pF Ph 1 to Ground	128.200	131.800	94.500
ohm Ph 1 to 2	0.00334	0.00336	0.00358
ohm Ph 2 to 3	0.00337	0.00344	0.00360
ohm Ph 3 to 1	0.00327	0.00328	0.00330
mH Ph 1 to 2	1.060	1.050	0.900
mH Ph 2 to 3	0.980	0.995	0.895
mH Ph 3 to 1	1.035	0.960	0.880
Average Inductance	1.025	1.000	0.890
% Res. Imbalance	1.70	2.34	0.39
% Ind. Imbalance	4.39	4.83	4.67

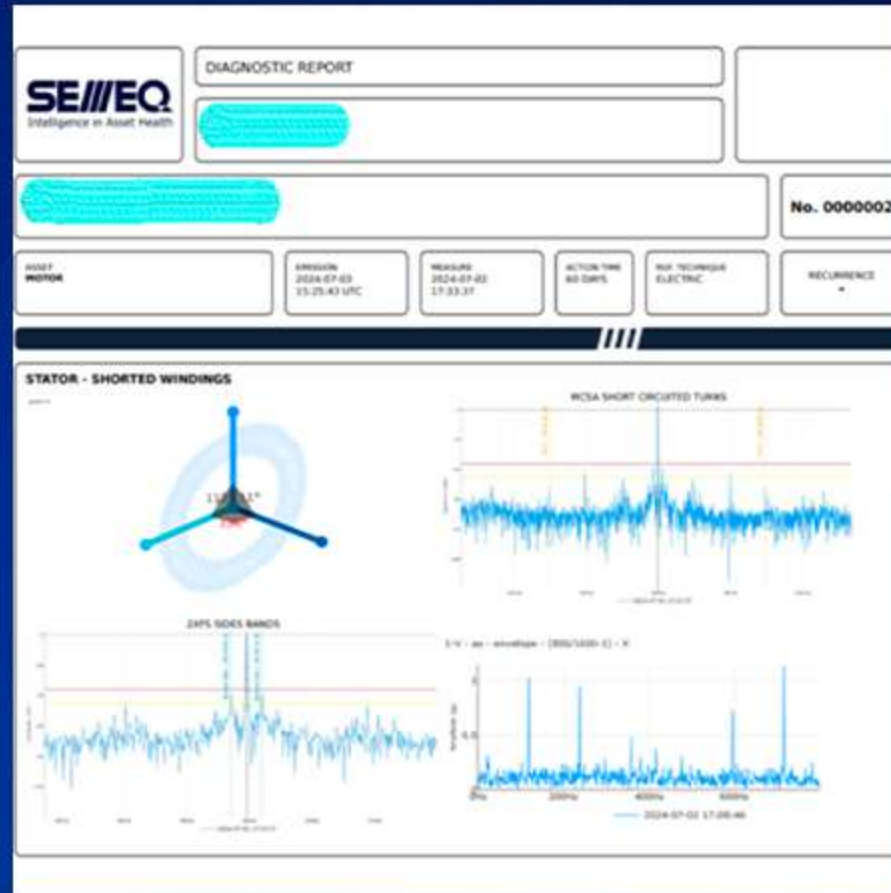
We conducted the complimentary MCA test and found some interesting insights! It revealed that the Main Motor Saw 1 has poor isolation and there is notable rotor eccentricity in Main Motor Saw 2. Exciting opportunities for improvement!

We have two important reports! Monitor the online data for the Main Motor Saw 2 and prioritize rebuilding the Main Motor Saw 1. These actions had a significant impact!

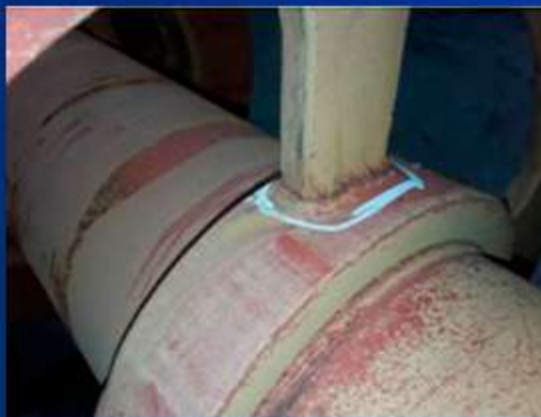
After maintenance, the assessment of the motor revealed cracks in the rotor bars, excessive dust, and the presence of water in the stator, which were diagnosed using the sensors.

Rotor crack

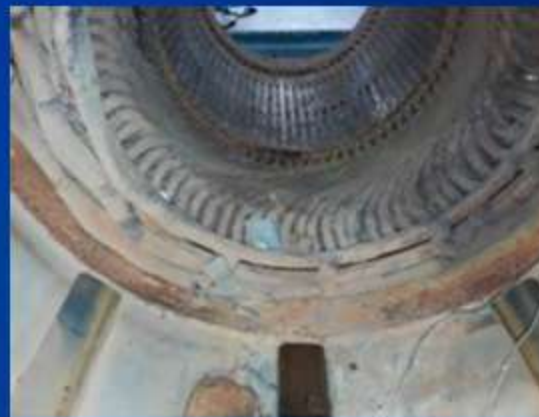
Excessive dust

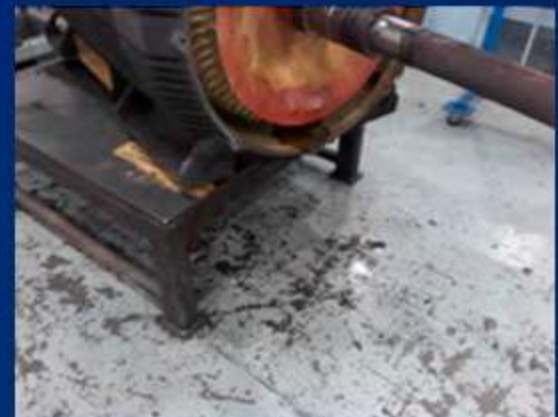
Water presence

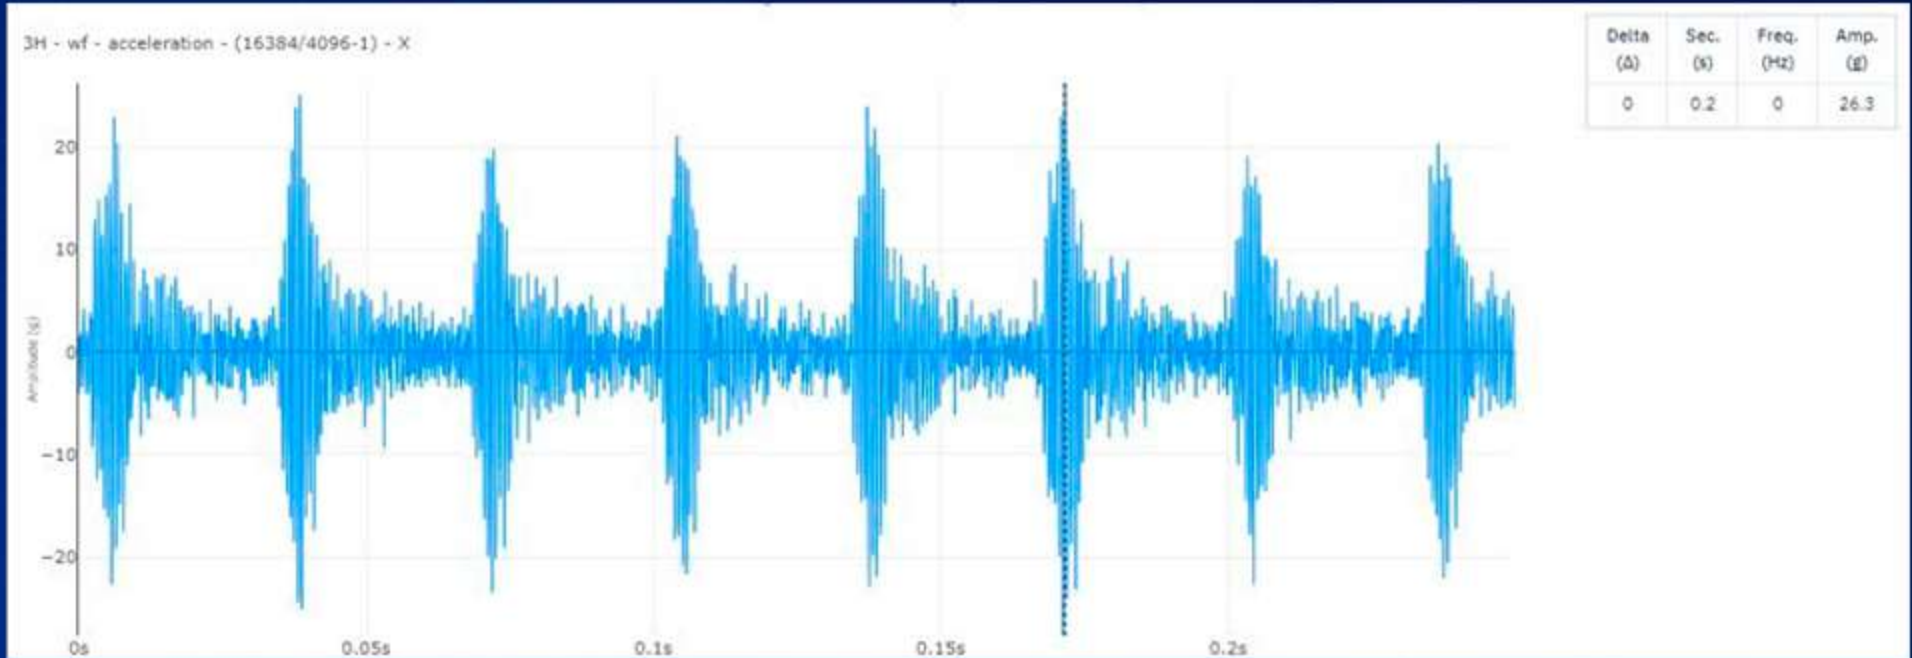
We observed some rotational looseness in the input bearing. After monitoring the data closely, we recommended a gearbox overhaul once the amplitude levels rose, ensuring optimal performance!

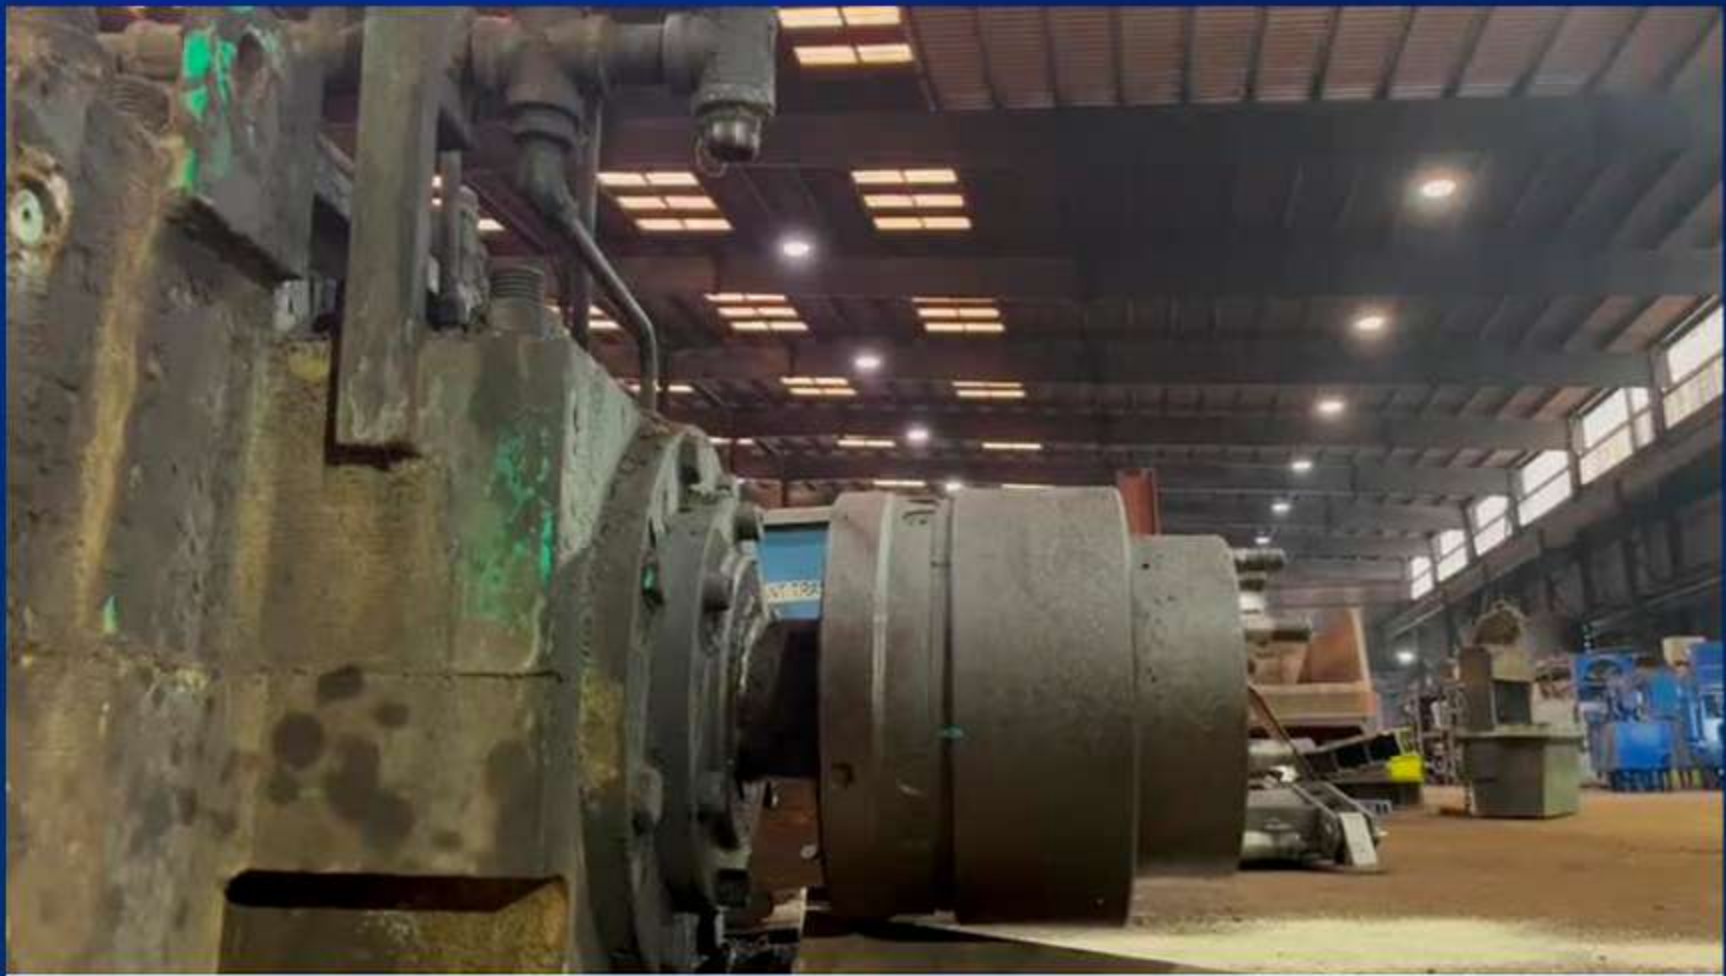
It was discovered during the assessment that there was excessive clearance between the shaft and the housing.
