Bulletin SEMEQ

SEMEQ / STEEL MILL COMPANY

Focus on Predictive Maintenance

Melt shop - Near Net Caster - 2 Fresh Water Pump

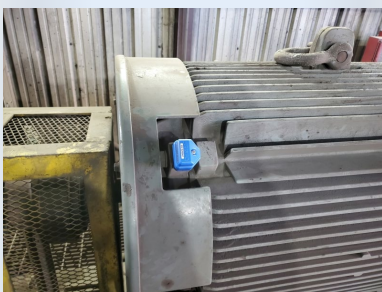
Diagnostic: Mounting Shaft Looseness

Component: Bearing

Recommendation action: The vibration level increased around the bearing resonance frequency in acceleration RMS and harmonics of 1x machine speed frequency were shown on the envelope spectrum. It is normally caused by excessive clearance of the bearings and fixing the looseness between the shaft and the bearing housing.
