**Save 800 mil dollars  
we explain**

# COST AVOIDANCE

# ONLINE SYSTEM

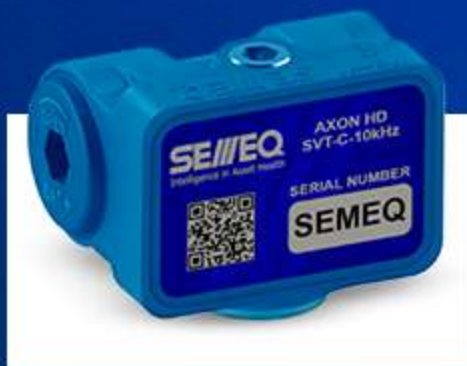
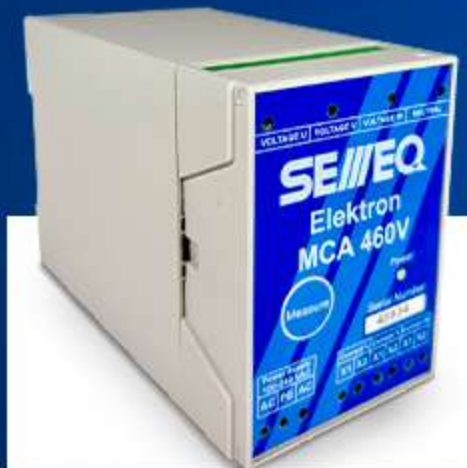
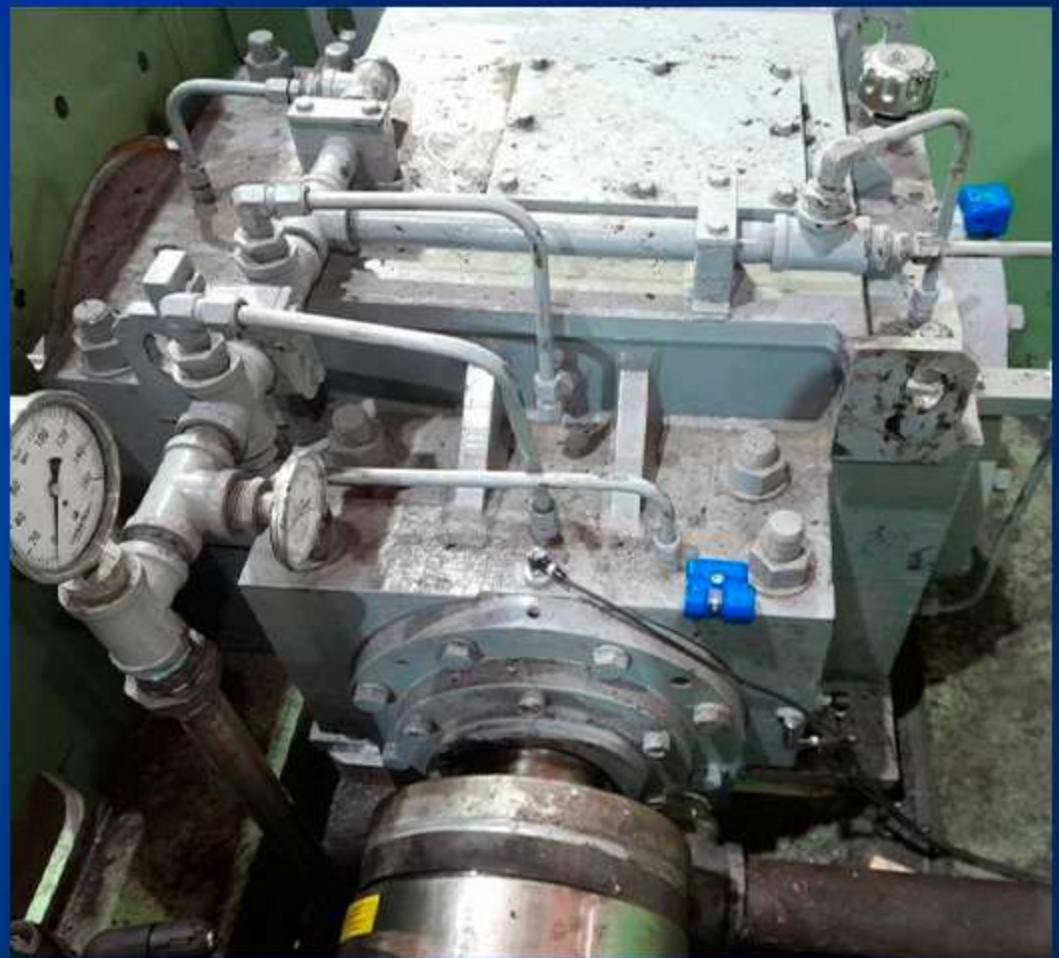
We installed Axon HD vibration wireless sensors and the Elektron MCA 460V sensor to monitor the mechanical and electrical conditions of the electric motor and gearbox.

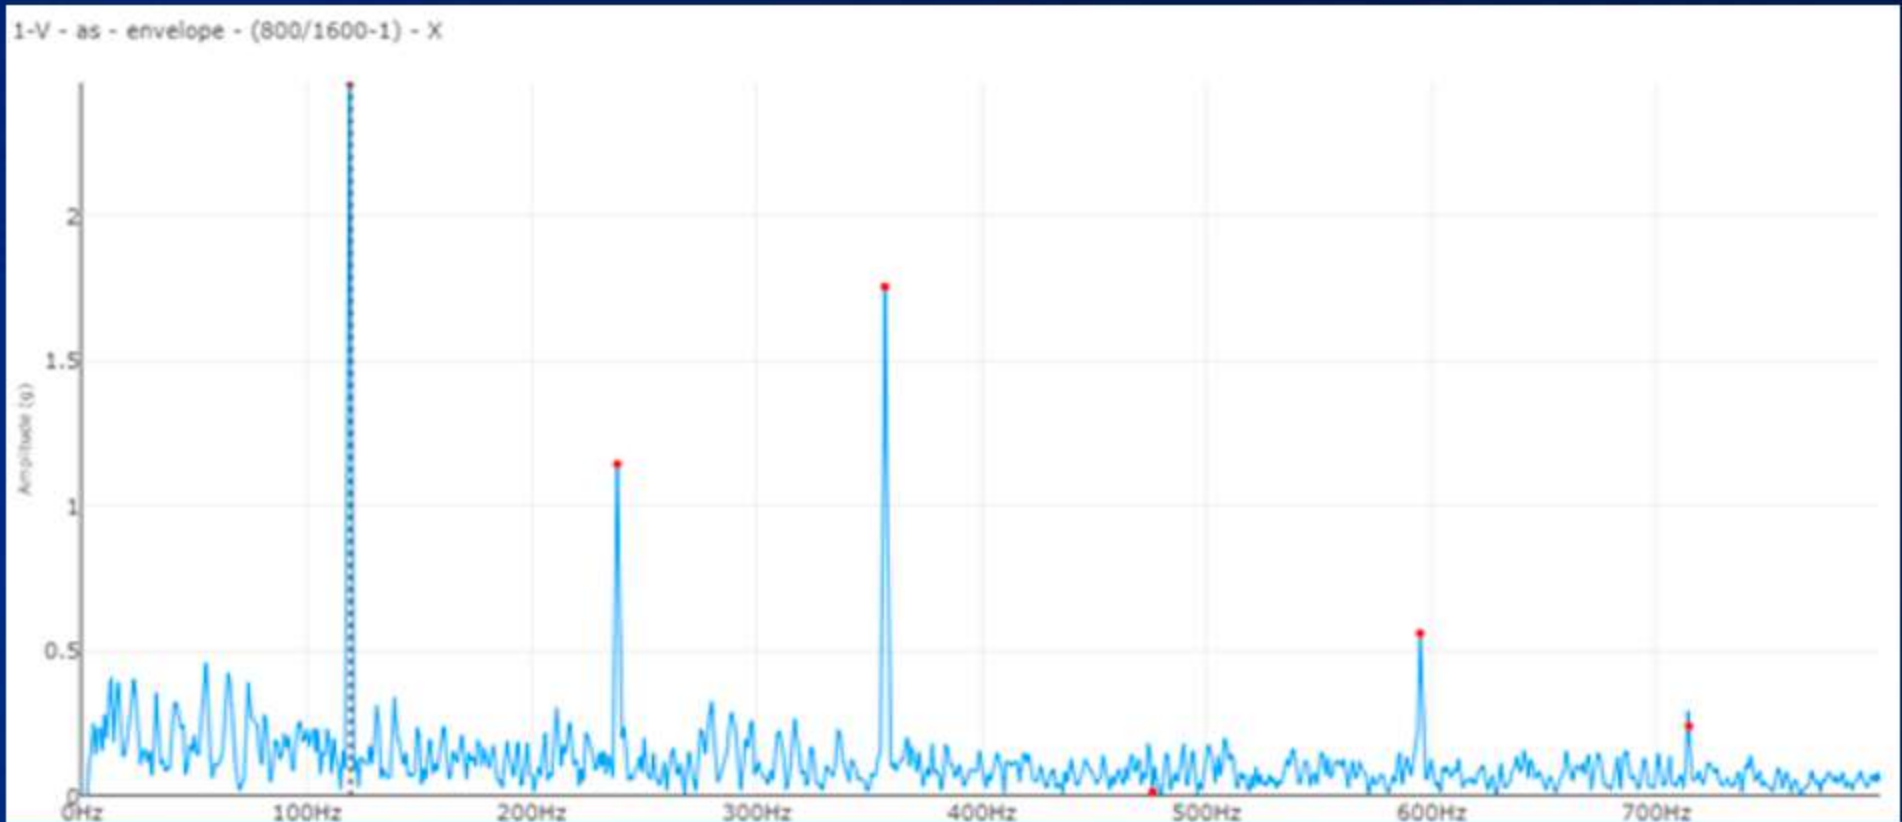
The vibration system identified an electrical frequency of 120 Hz—twice line frequency—suggesting an electrical issue. We observed an amplitude of around 2.5g in the envelope for the main motor. Let's explore this further together!
